Reed Canarygrass Monitoring Program 2020 Year-End Field Report: Irely Creek

Installation of Irely Creek Monitoring Equipment

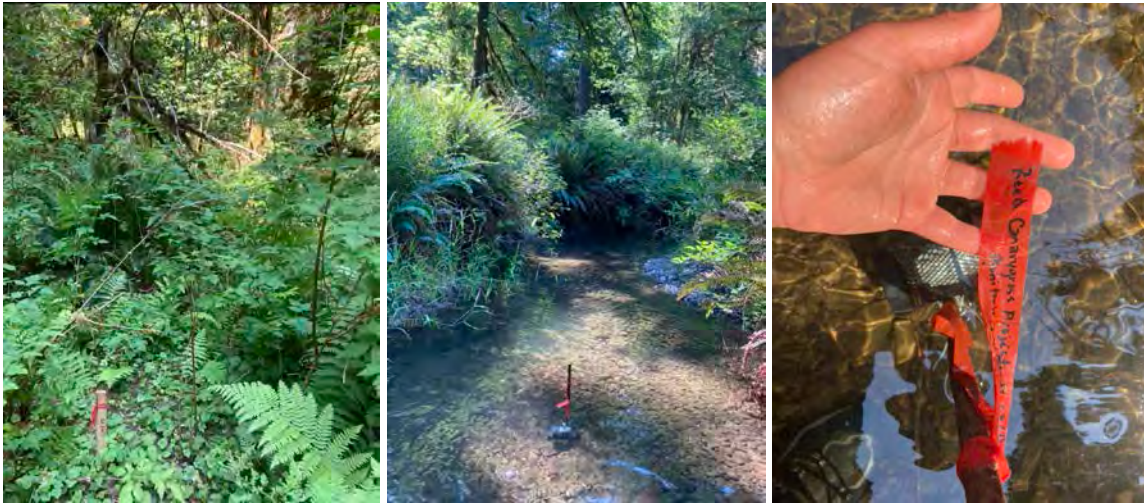
Figure 2a. (left) Example of either left bank or right bank transect demarcations in Irely Creek.
Figure 2b. (center) Example of original temperature logger installation (at ICT2), including rebar, crab bait cage and HOBOPendant™ temperature logger. (This location is far from view of hiking trail.)
Figure 2c. (right) Example of biodegradable flagging, attached to rebar for temperature logger.

Transects were installed perpendicular to the direction of flow, marked with wooden stakes located 30-feet from each bank on either side of the wetted stream channel (Figure 2a). Stakes were augmented with red biodegradable flagging in areas where installations were difficult to see (Figure 2c). As requested by NPS, flagging was not used in proximity to trails or publically-accessible areas.

HOBO Pendant™ temperature loggers were deployed in-stream along each transect (Figure 2b, Figure 3a). These temperature loggers were set to collect measurements (°C) at 20-minute intervals. Due to multiple channels or off-channel habitat, additional water temperature loggers were installed in Transects 4 through 8 (ICT4, ICT5, ICT6, ICT7 and ICT8).

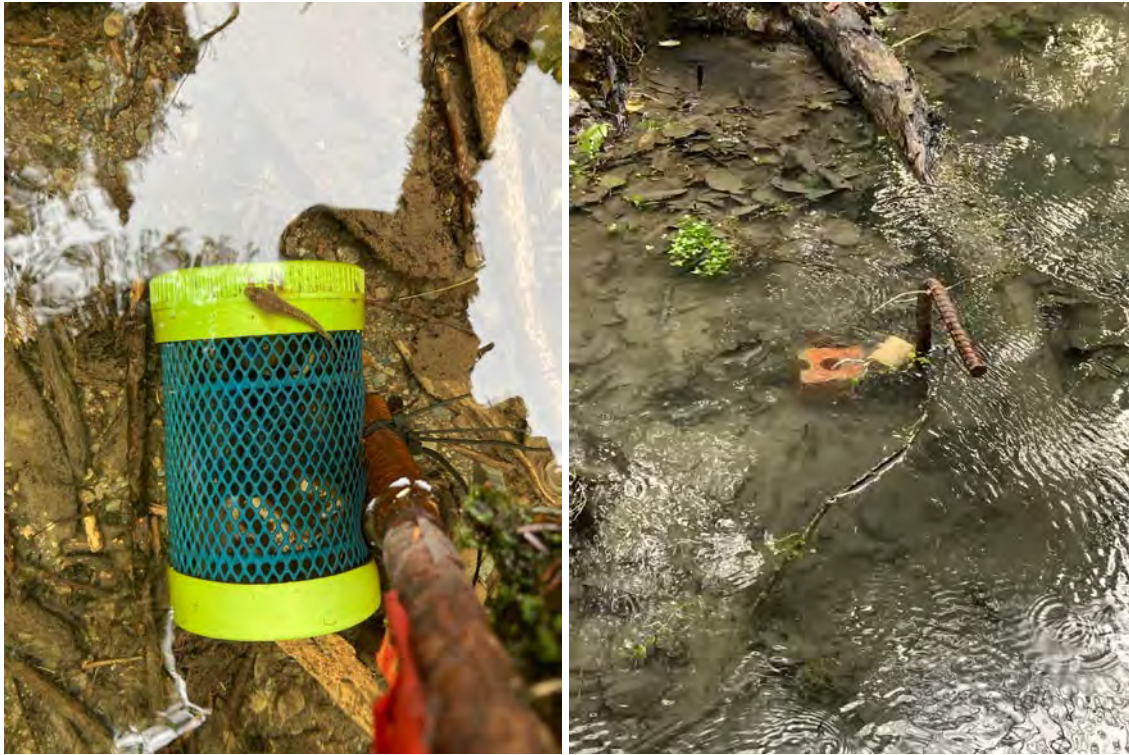
Figure 3a. (left) Original housing for the HOBO Pendant™ temperature logger consisted of a crab bait cage attached to rebar by several exterior use zip-ties. **Figure 3b.** (right) Updated housing consists of a 2” PVC pipe covering for the temperature logger and a half brick to weight the system. The system is attached to rebar via tar-coated parachute cord. These updates were implemented on October 7, 2020.

Updates were made to the housing of the water temperature loggers on October 7, to ensure durability and continued operation throughout winter 2020/2021. The temperature loggers were reinstalled in a 2” section of 1.5” diameter PVC pipe, and weighted with a half brick (Figure 3b). This design is modeled after the Olympic Experimental State Forest’s (OESF) T-3 Stream Temperature Study^{5,6,7}.

The RCMP installation technique differs from the T-3 stream temperature study methods in one critical way; the PVC pipe in our study is attached to rebar. The decision to use rebar was made due to the lack of stable ‘natural’ mounting locations, and so the original placement locations could remain precise.

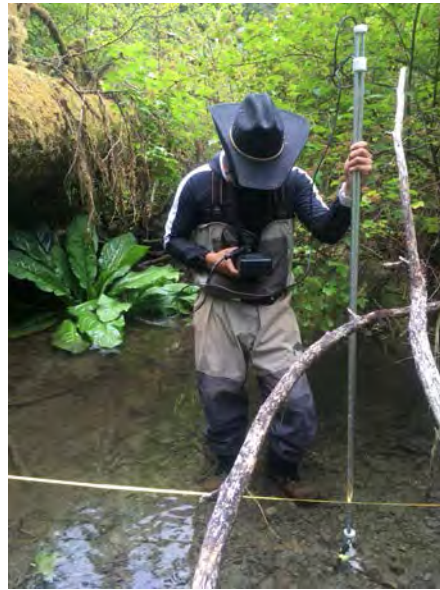
Figure 4. Field technician Miguel Rodriguez sampling flow in Irely Creek using a Swiffer flow meter (Model 3000) on July 3, 2020.

- Temperature data was uploaded once per month from the HOBO Pendant™ data loggers throughout summer. The equipment remains in Irely Creek for data collection throughout winter 2020/2021.
- Dissolved oxygen was collected using an optical meter (Hanna Instruments Model 98198) near each temperature logger.
- Flow velocity was measured near each transect, in areas of sufficient depth and minimal flow interference (e.g. downed wood or sharp curves in the stream). A Swiffer flow meter (Model 3000) was used to calculate depth and flow velocity (ft/s) at numerous intervals across the stream (Figure 4). After ten transects were successfully completed, a replicate measurement was collected for quality assurance purposes.

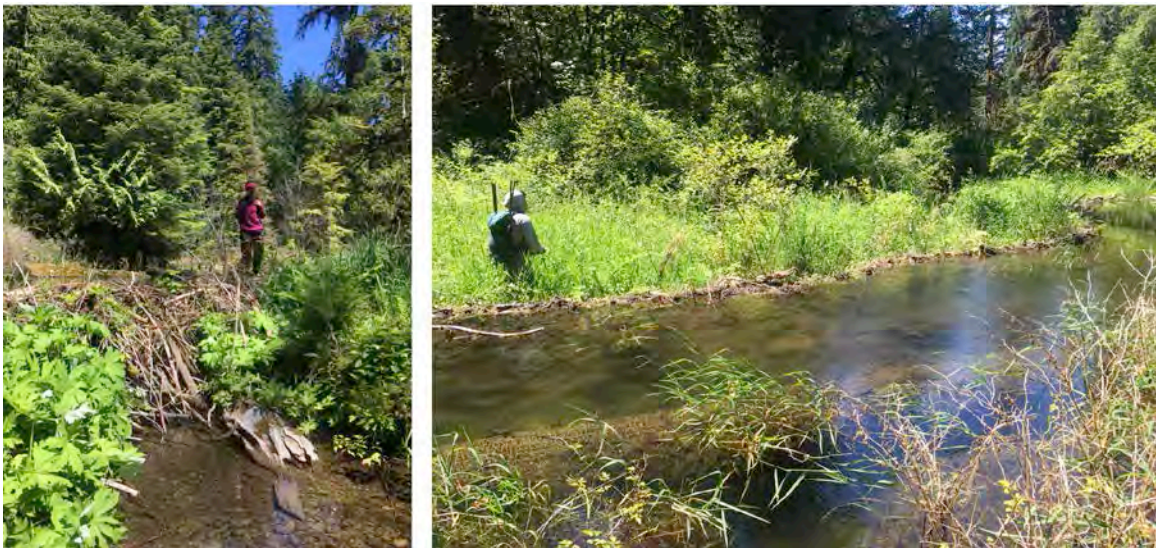
Figure 5a. (left) Upstream view of the large beaver dam, as seen from the Irely Creek Transect 7 (ICT7) primary channel. Photo was taken on June 25, 2020. **Figure 5b.** (right) Downstream view of beaver dam from ponded area between ICT6 and ICT7. *Phalaris arundinacea* (PHARU) can be seen in the foreground along a log submerged in the pond, densely established along the dam, with native vegetation in the background outflow area. This photo from June 25, 2020, covers approximately one-third of the beaver dam's lateral width.

The site conditions at Irely Creek were affected by two significant factors in 2020; beaver activity and summer low flows. Since original scouting of the study reach in 2019, the site has been significantly altered by beaver activity and dam construction. During installation of the monitoring equipment, a five-foot high beaver dam was discovered spanning the creek for approximately 200 feet. The dam had impounded flow, creating a pond approximately 200-feet long, affecting Transect 6 (ICT6) (Figure 5a,b). Outflow from the beaver dam spreads laterally into several diffuse and braided channels affecting Transect 7 (ICT7).

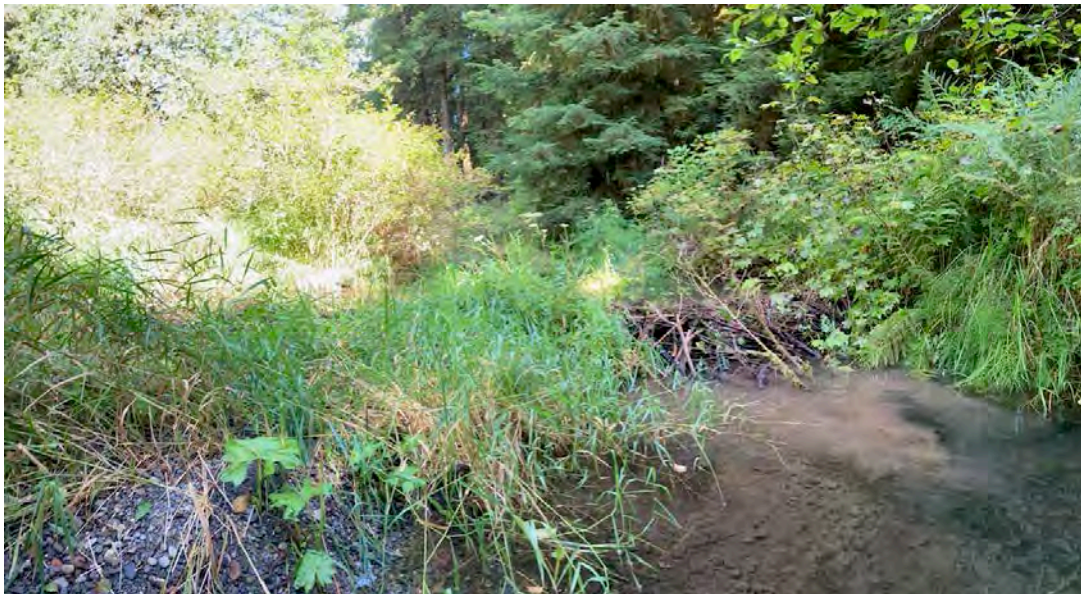
Figure 7. View of the beaver dam discovered 328-feet (100m) downstream of the study reach. This dam caused ponding, affecting Irely Creek Transect 10 (ICT10) from late August through October. Photo was taken downstream of the dam, facing upstream, on August 26, 2020.

By August 25, beaver activity had moved further downstream. A smaller dam approximately 2.5-feet high and 12-feet wide was discovered 328 feet (100m) below the study reach (Figure 7). This new activity led to ponding in the furthest downstream transect of the study reach, Transect 10 (ICT10).

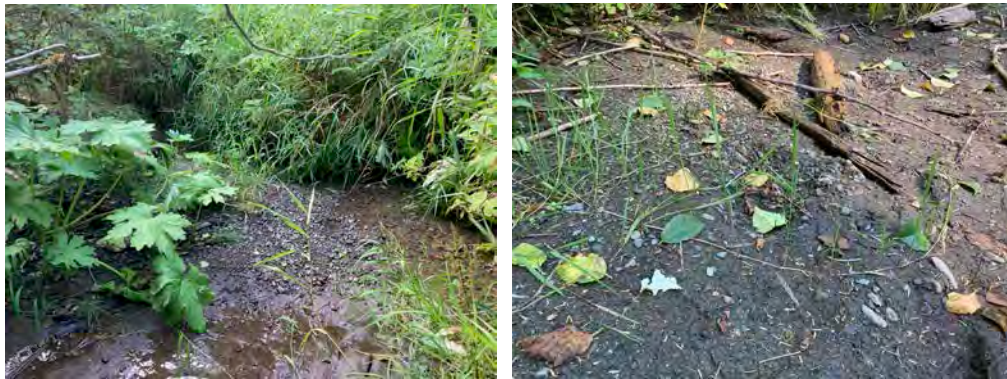
Figure 8a. (left) Discharge has fallen at Transect 7 where velocity is often measured. Photo taken on August 25, 2020. **Figure 8b.** (right) Reed canarygrass (*Phalaris arundinacea*) observed spreading into the dry streambed of Irely Creek during late summer low-flows. Photo taken on September 9, 2020.

Seasonably low precipitation in August caused a considerable drop in stream discharge by late summer. By August 10, the creek was no longer flowing along the hiking trail. The low discharge eventually resulted in the upper reach of the creek (upstream of ICT6) to dry out completely. By September 8, the upper half of the study reach had become reduced to disconnected puddles, preventing adequate flow velocity measurements (Figure 8a). These low flow events are likely an annual trend in mid- to late-summer for Irely Creek, and it is expected that the occurrence of dry channel segments will be especially prominent during drought years. These drought events result in the deposition of *PHARU* stem fragments and rhizomes, expanding invaded area (Figure 8b).

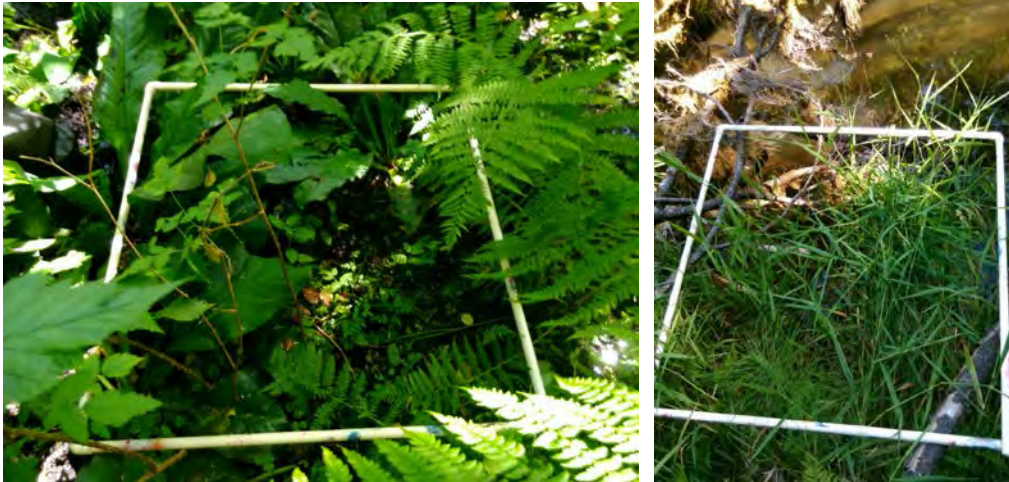
Figure 9. Examples of the 1-square meter quadrat placement during the Irely Creek vegetation survey. To the left is an example of the diverse riparian vegetative character found in the area, and to the right is an area invaded heavily by *Phalaris arundinacea*.

The annual vegetation survey took place over four days at Irely Creek. The survey was conducted in July, the most optimal time for grasses to be in florets, and therefore, most easily identified. A square, 1-meter quadrat was placed at ten equal intervals along each riparian (cross-stream) transect, similar to the methodology in which PAR is measured (Figure 9). Each plant found rooted within the quadrat was identified to species level, and percent cover was visually estimated and recorded. Species richness of the Irely Creek study reach equals 69 species (Appendix B).
